CONCRETE AND ROCK CORE TESTS
MAJOR REHABILITATION OF STARVED
ROCK LOCK AND DAM, ILLINOIS WATERWAY
CHICAGO DISTRICT, PHASE I, REHABILITATION

Richard L. Stowe, Barbara A. Pavlov, Ging S. Wong

September 1978

Prepared for U. S. Army Engineer District, Chicago
Chicago, Ill. 60604

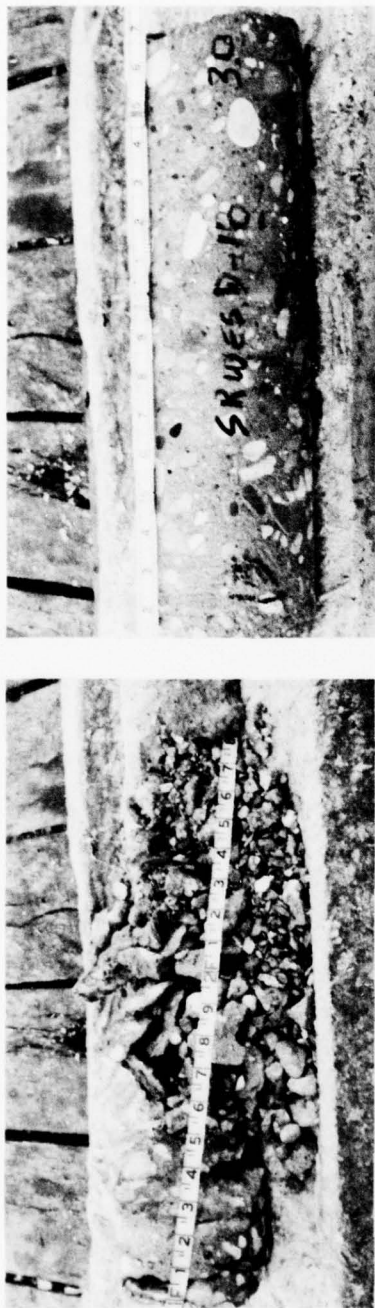
36. The concrete core varied greatly in its physical condition over the project (see Figures 3 and 4). Some core was so badly deteriorated (broken to gravel-size pieces) that intact samples could not be obtained for testing. Therefore concrete test specimens were selected from the intact near surface portion and the bottom portion of the core. The near surface core sometimes contained cracks but remained intact. This procedure was used for the short core and for core with lengths up to 5.1 ft. For the deeper borings, GW-1 and GW-2 test specimens were selected from the near surface, middle, and bottom portions of the core. Characterization properties, effective (wet) unit weight (γ), compressional wave velocity (V_p), and compressive strength (UC), and engineering design properties Young's Modulus (E), and Poisson's ratio (ν)* were determined or calculated. Test assignment locations can be gotten from appropriate tables of test results.

Figure 3. Concrete core from ice chute pier (horizontal boring SR WES D-18-77) showing broken condition of core

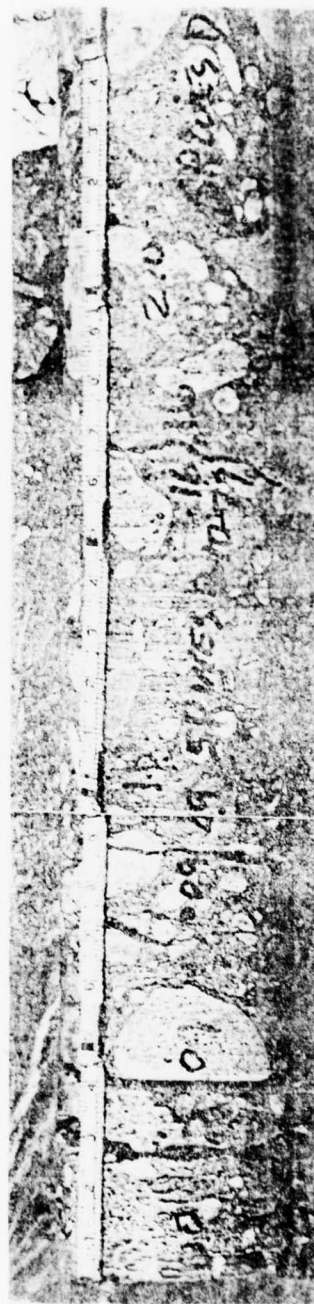
Figure 4. Concrete core from tainter gate pier No. 2 (horizontal boring SR WES D-10-77) showing subparallel cracking due to frost action

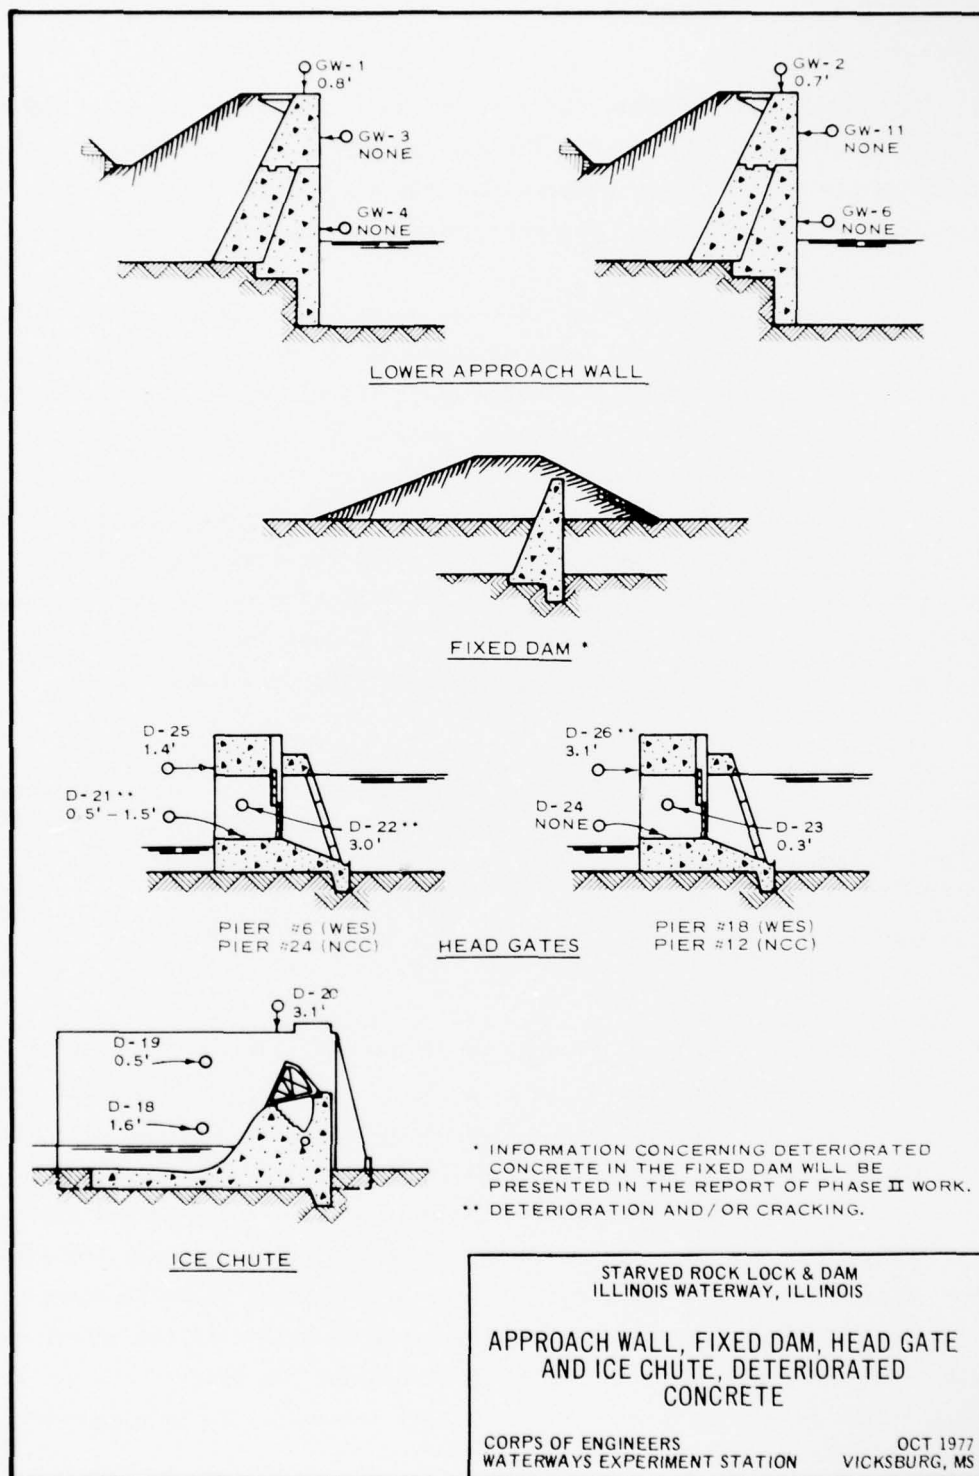
79. Depth of Deterioration. There were two vertical borings drilled into the lower approach wall and four horizontal borings. No new concrete was encountered in these borings. The results of frost damage was evident

Figure 5. Deteriorated concrete in lower approach wall

in the two vertical borings, however, no frost damage was detected in the horizontally drilled core. The average depth of frost-damaged concrete in the core from the vertical borings was 0.75 ft. The maximum depth was 0.8 ft. Figure 5 presents details of the damaged concrete in the lower approach wall.

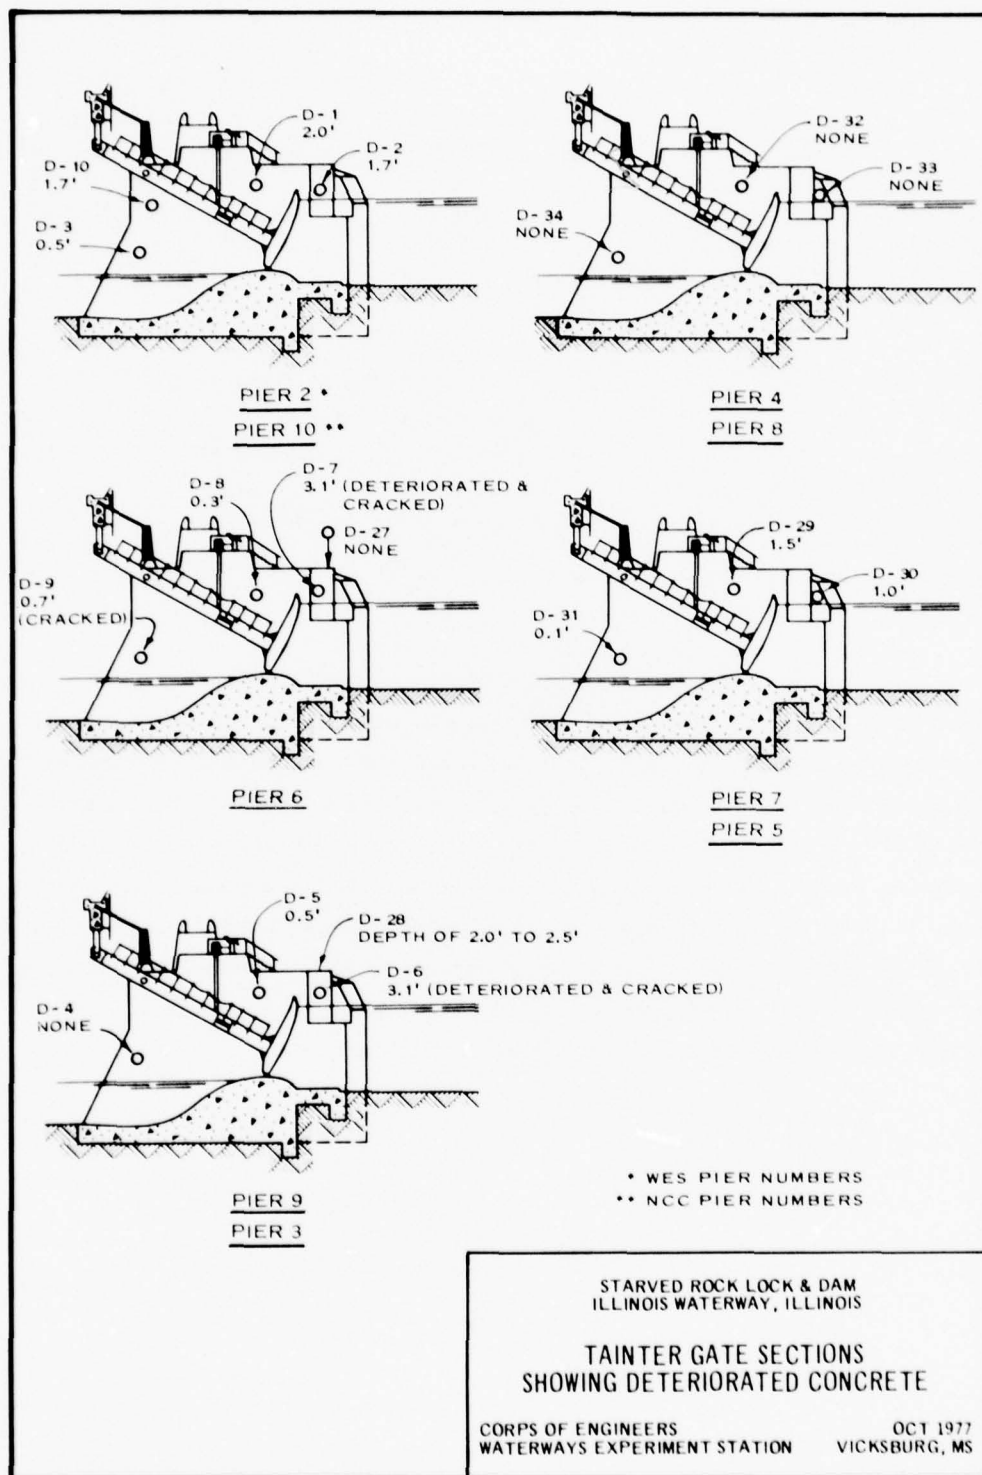
92. Average Physical Properties. The average physical properties of the severely and moderately deteriorated concrete from the tainter gate piers are presented below:

Figure 6. Location of deteriorated concrete, tainter gate sections

One or more of these companies may have had experience with injecting epoxies or chemical grout into porous concrete. It is assumed that the techniques used would be different than techniques used for injecting these materials into single or multiple cracks. The effectiveness of such a procedure should be studied.

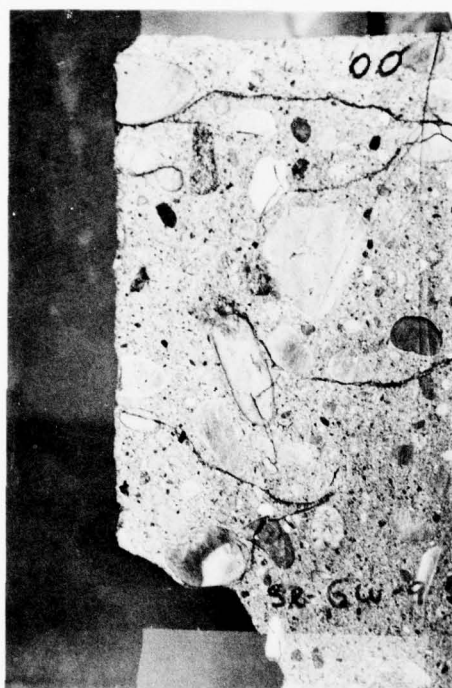
Photograph B1

Core SR WES GW-9-77 contained traverse cracks near the top of the core and incipient cracks deeper in the core.

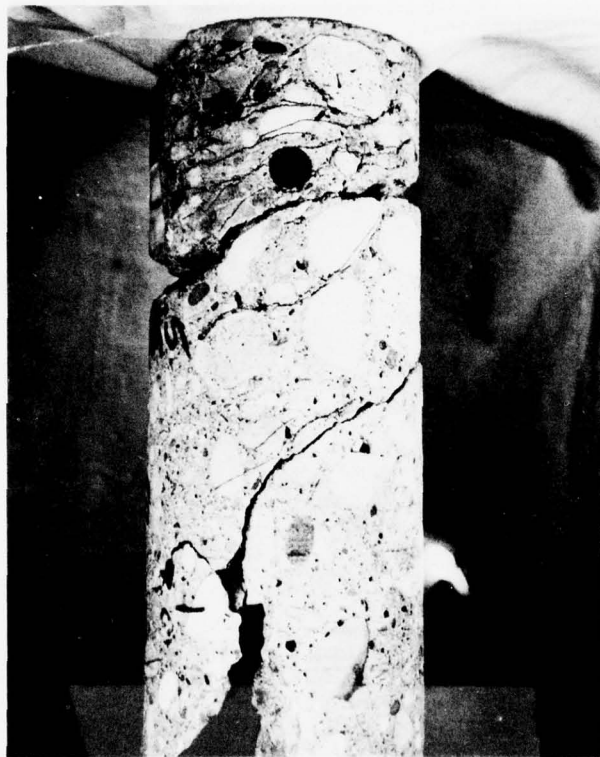
Photograph B2

Core SR WES D-22-77 is typical of several cores showing subparallel to parallel fractures going through both aggregate and paste indicating frost damage near the surface and a transition to horizontal cracking related to alkali-silica reaction deeper in the hole.

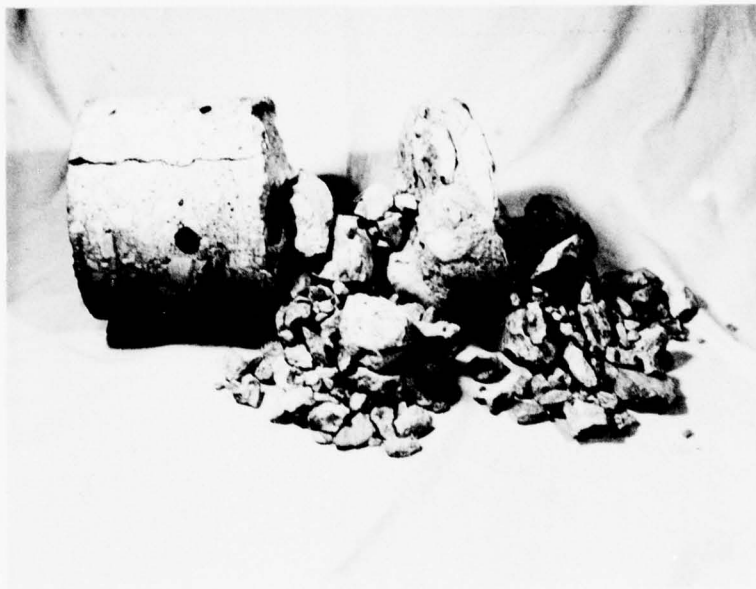
Photograph B3

Core SR WES D-1-77 has been resurfaced with a layer of new air-entrained concrete. The zone directly beneath the resurfacing was damaged by frost action and disaggregated during drilling.
